## Appendix B - Buggy Road Inspection

### Inspection Photographs

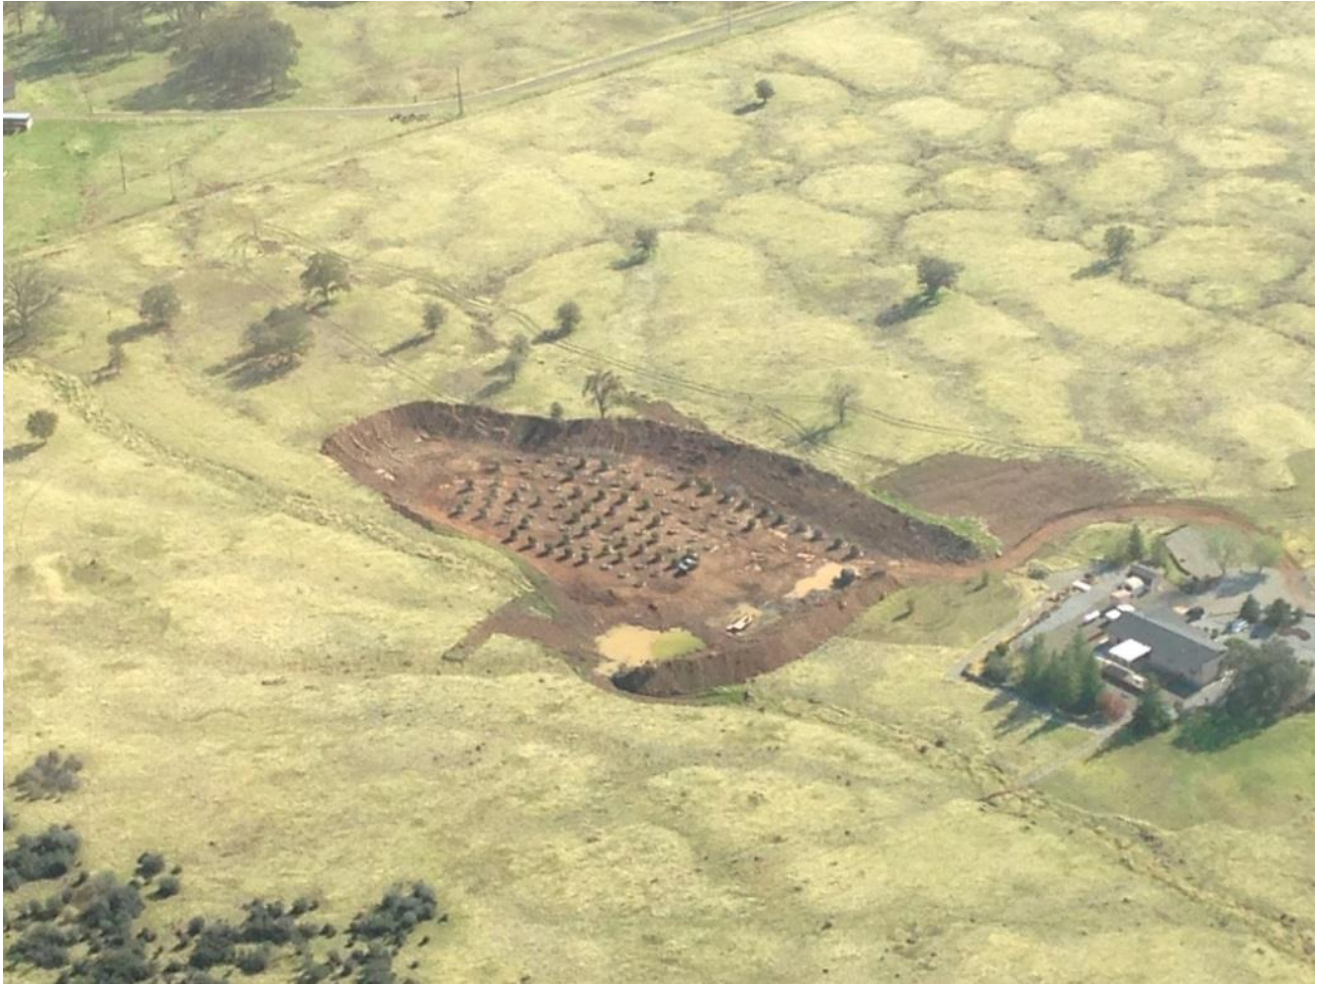
Photograph 1: Aerial photograph from the 5 November 2014 overflight showing potential for water diversion, lack of erosion control, and possible vernal pool topography suggested by the circular patterns in the landscape.

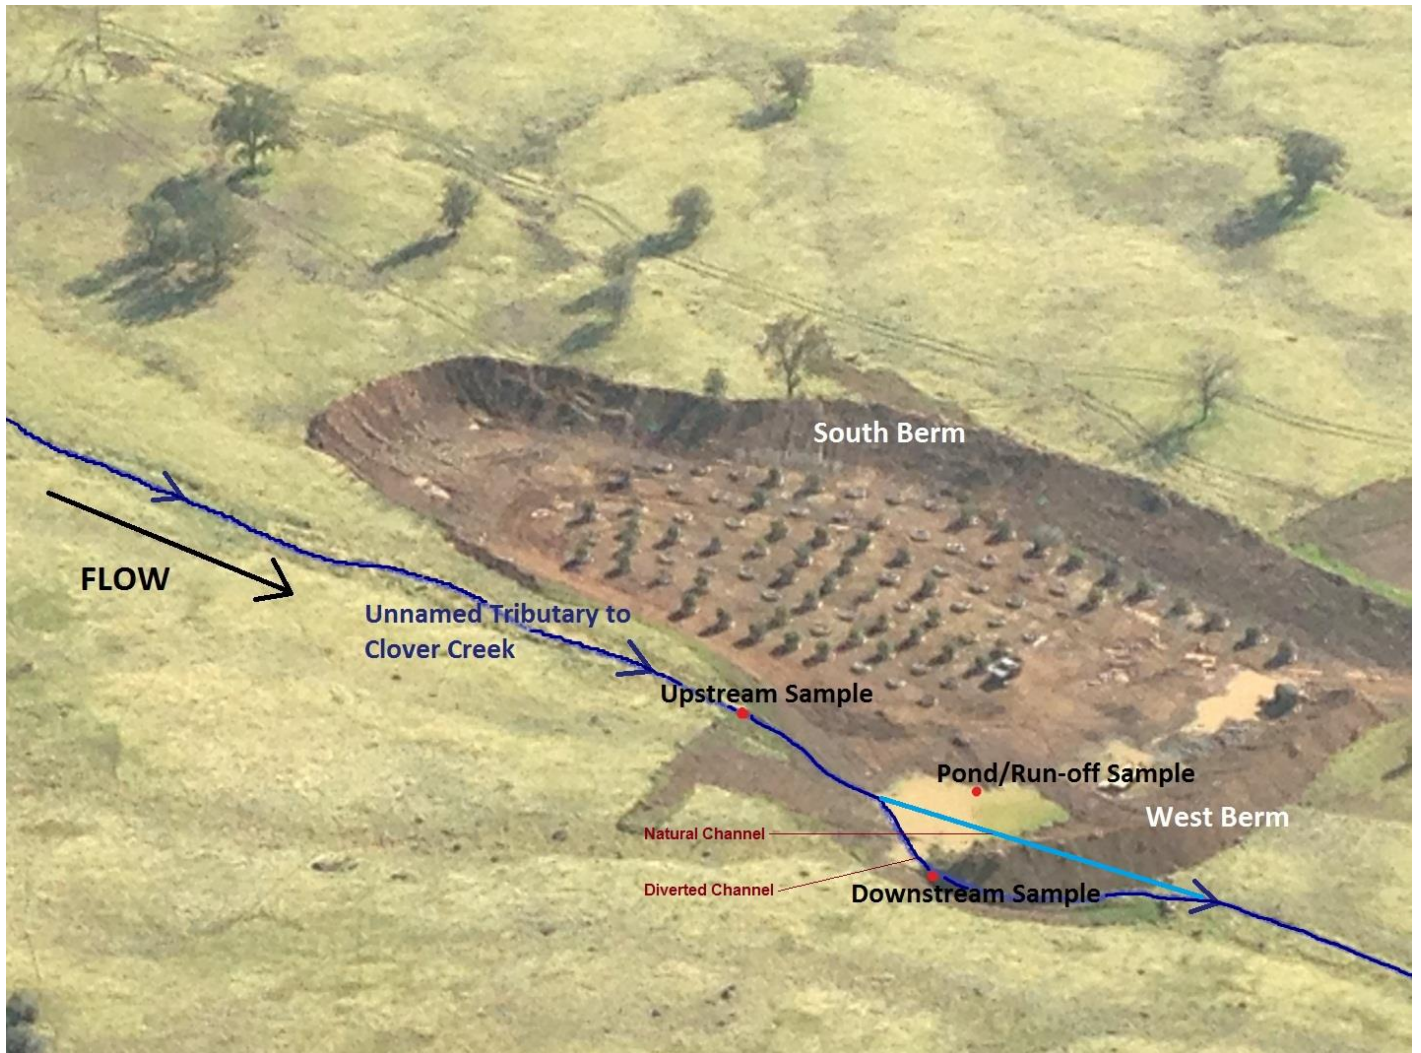
Photograph 2: Second and closer aerial view from the overflight showing ponding water along the western end of the site and potential algal blooms. Labeling shows the direction of flow observed in the stream (identifying both its natural and diverted channels) and identifies berms and sample locations.

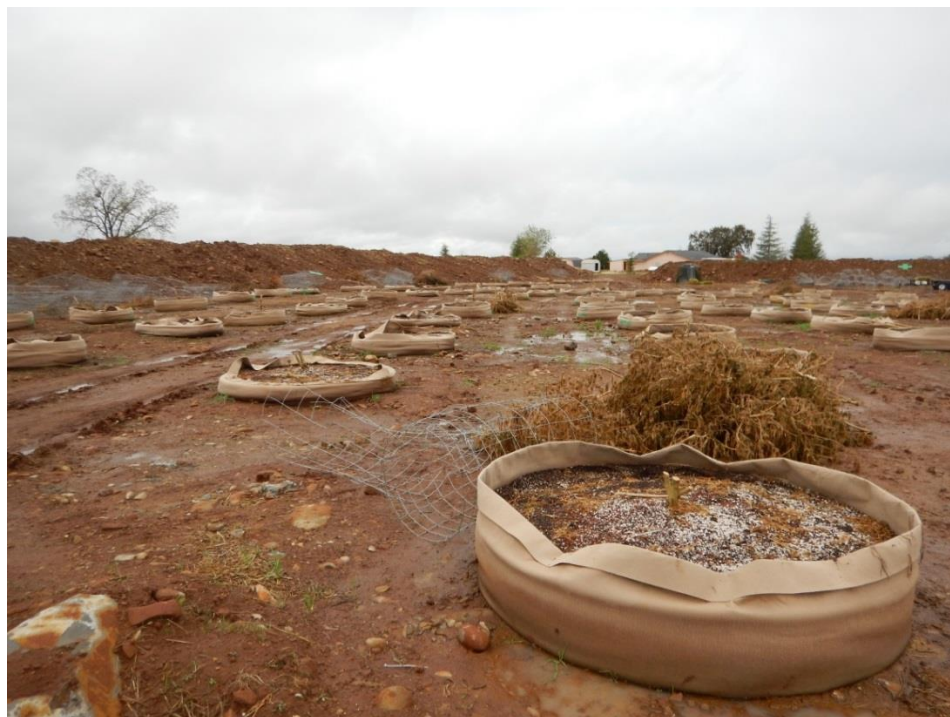
Photograph 3: View of grow site towards west and south berms showing the expanse of the grading/excavation and many of the 93 plant bags.

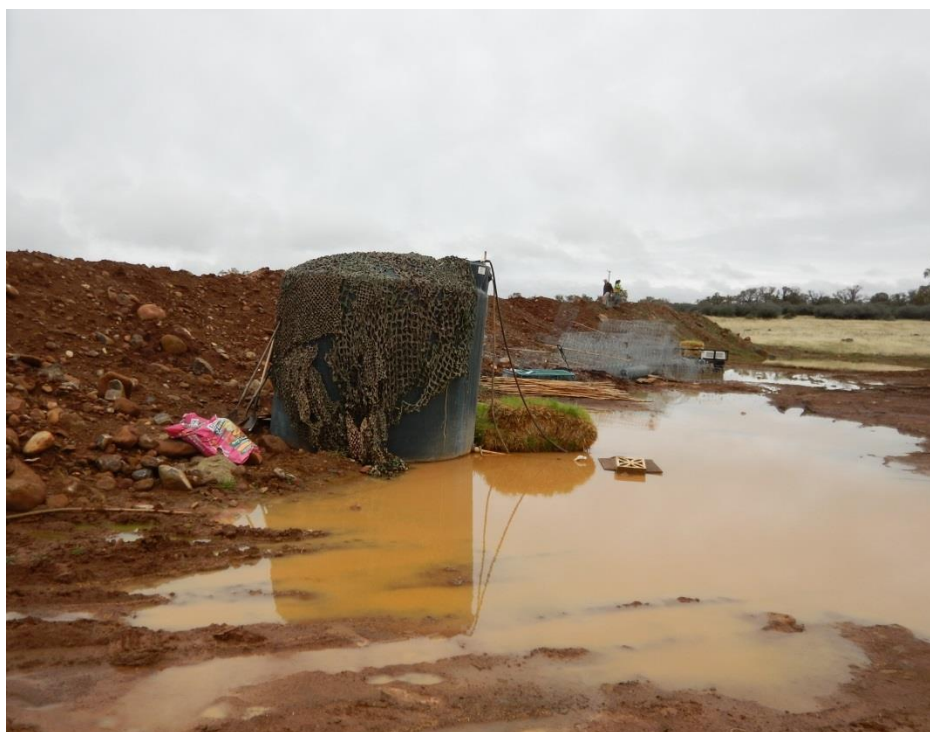
Photograph 4: View of the southwest corner/entrance showing ponding waters adjacent to large mixing tank with hoses stretching to the northwest end of the site.

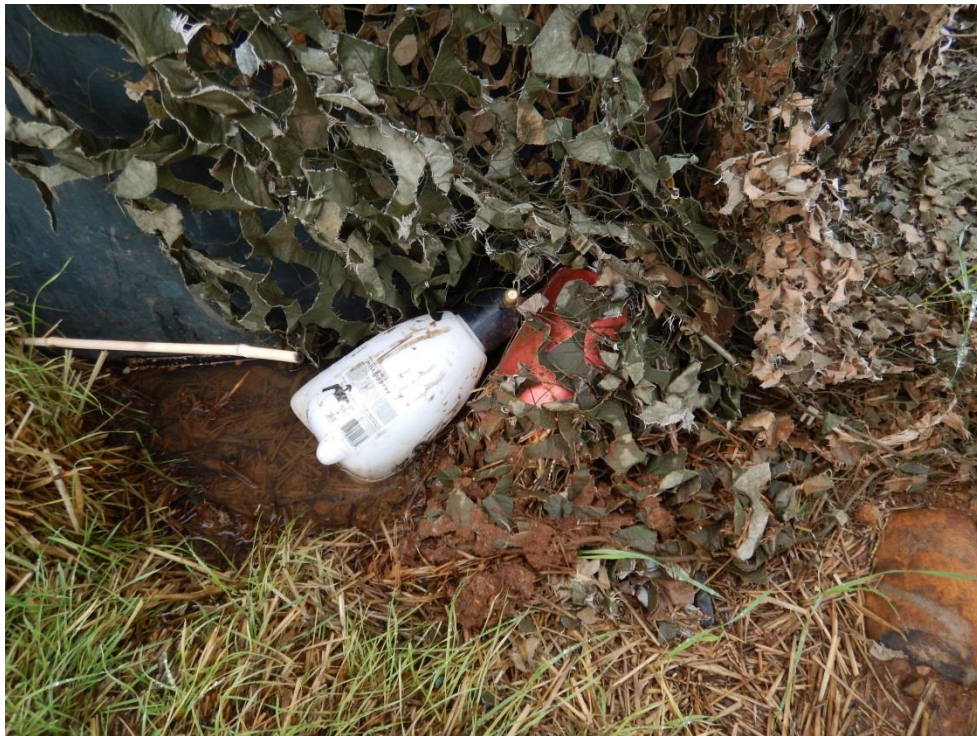
Photograph 5: Spray applicator adjacent to mixing tank.

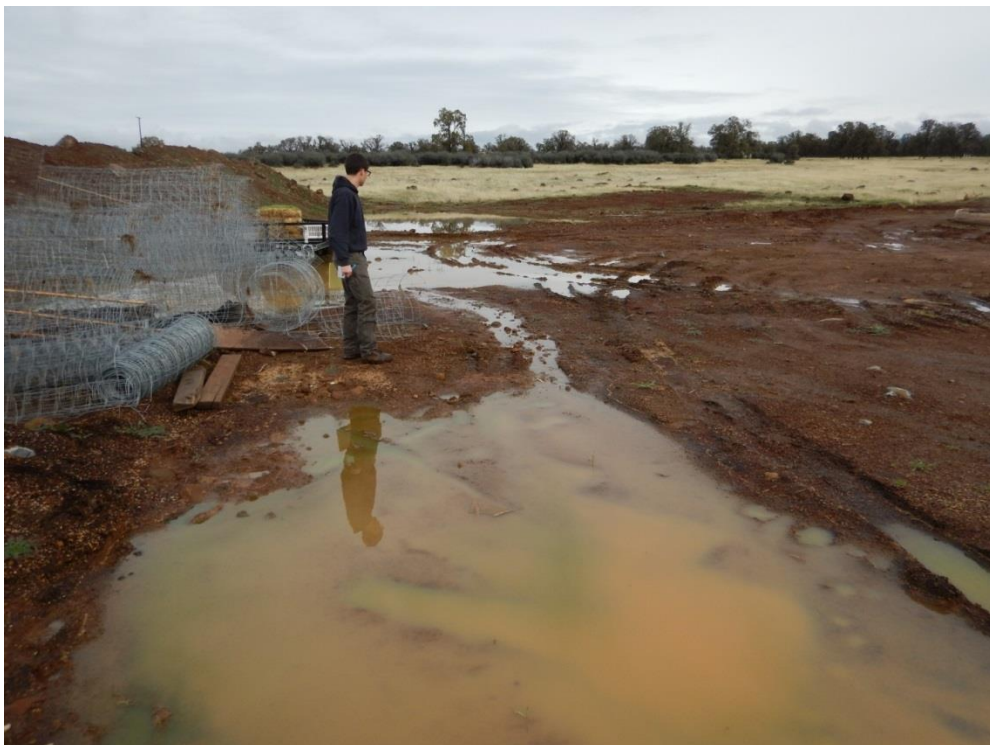
Photograph 6: Water in the southwest corner of the graded site showing evidence of turbidity and algal growth flowing to the northwest corner and intersecting the stream.

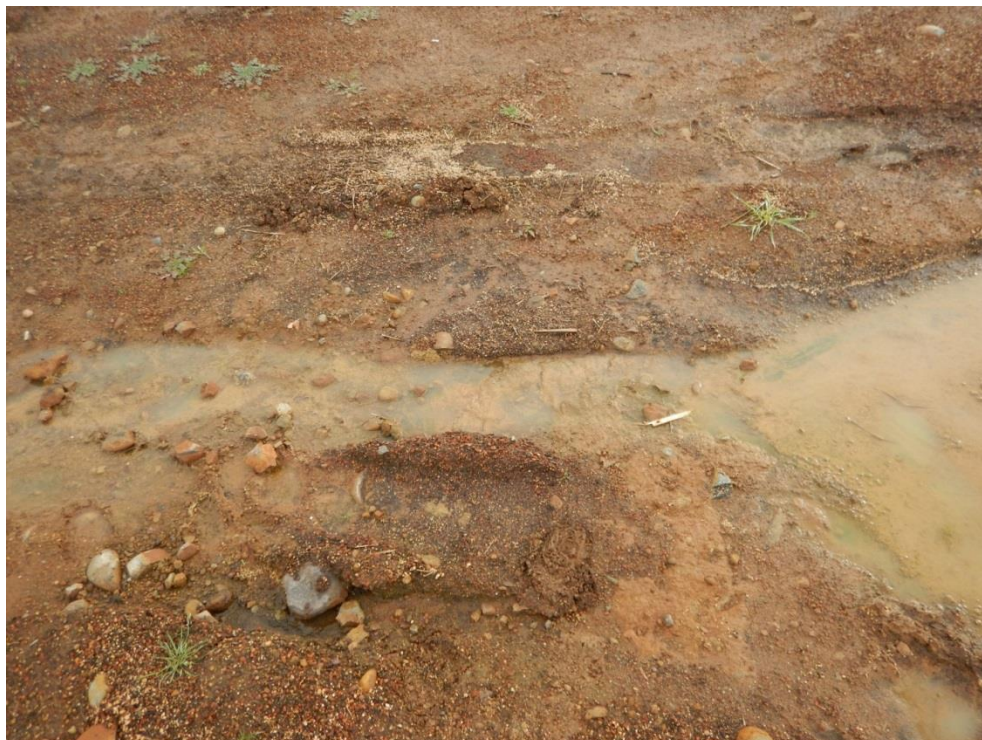
Photograph 7: Water flowing between ponding areas.

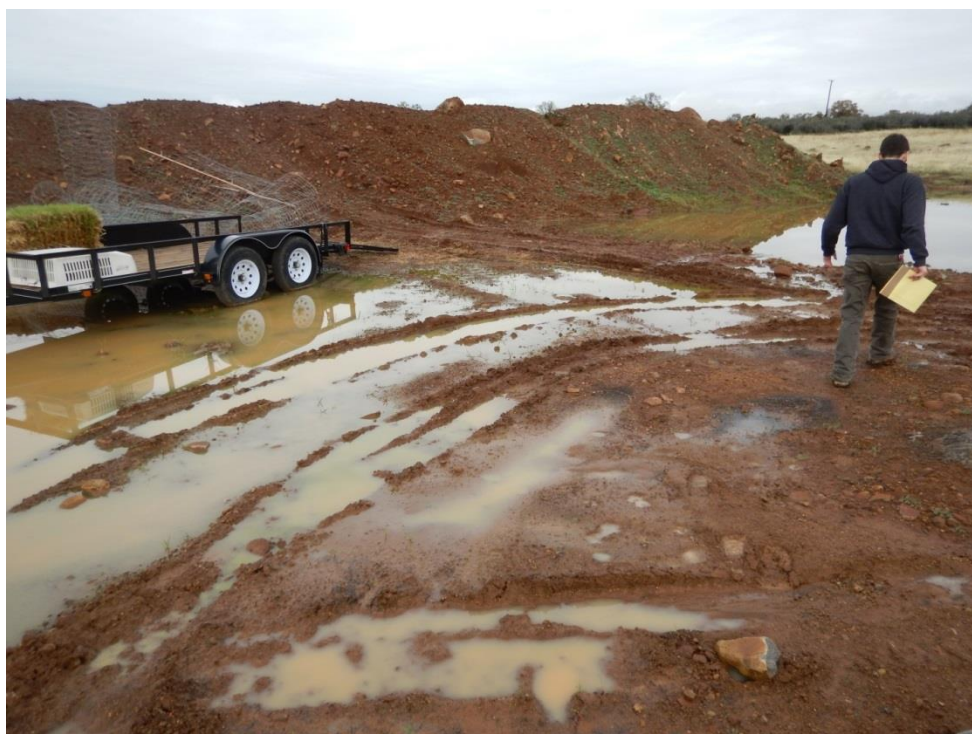
Photograph 8: Water flowing between ponding areas.

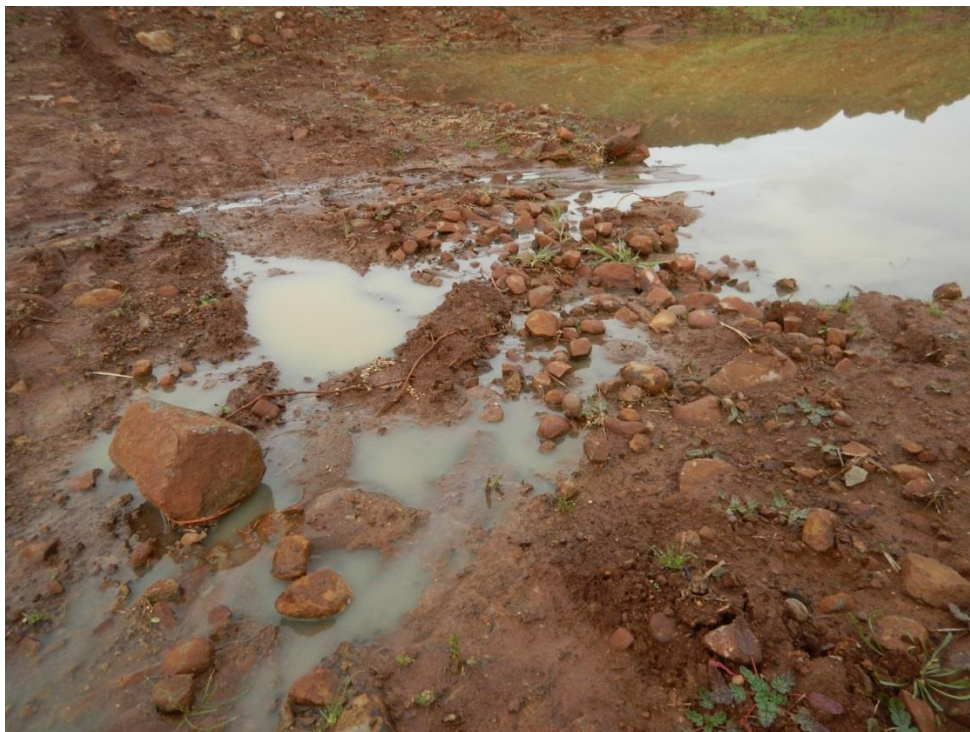
Photograph 9: Water flowing between ponding areas.

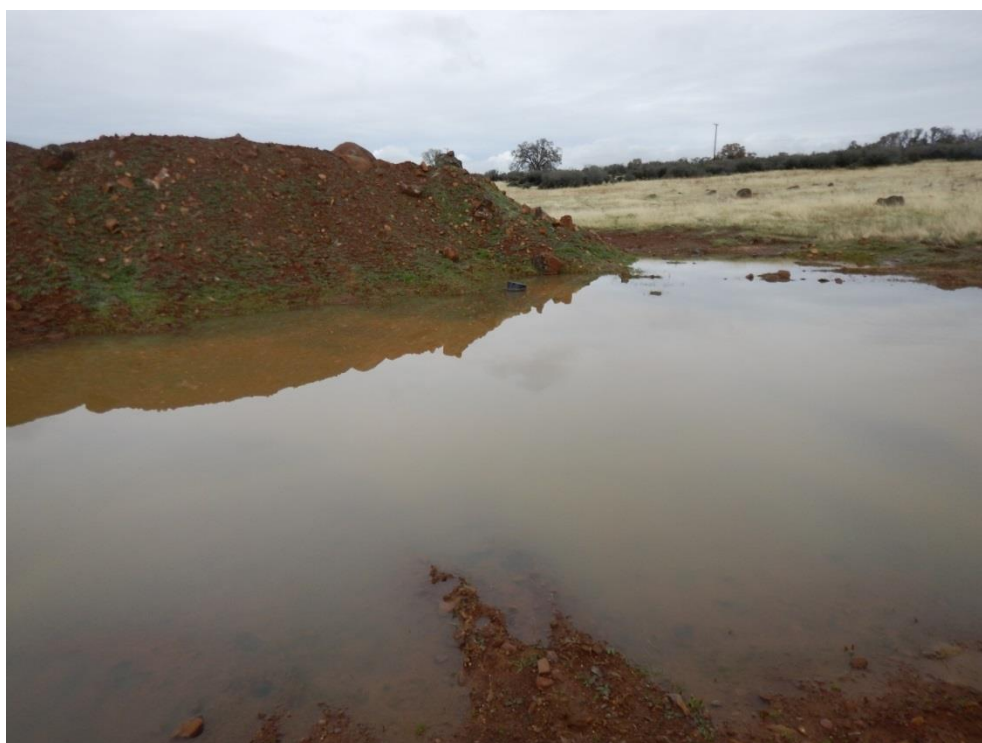
Photograph 10: Turbid water in the last ponding area intersecting with the stream at the northwestern edge of the unprotected berm.

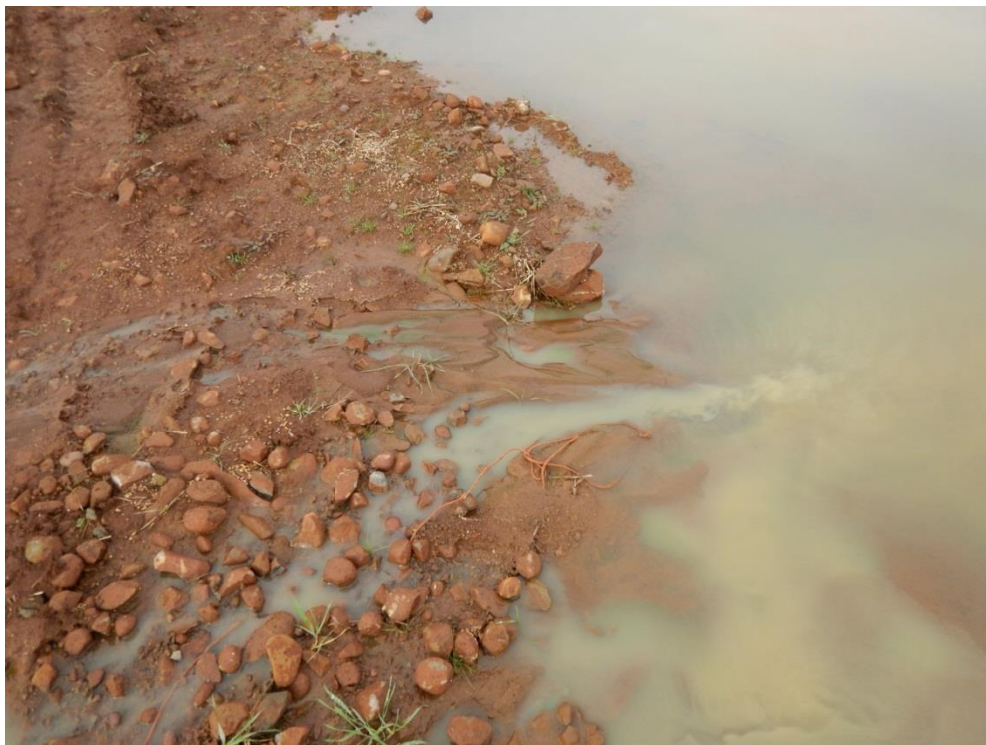
Photograph 11: Sediment plume flowing into last ponding area before discharge to the stream.

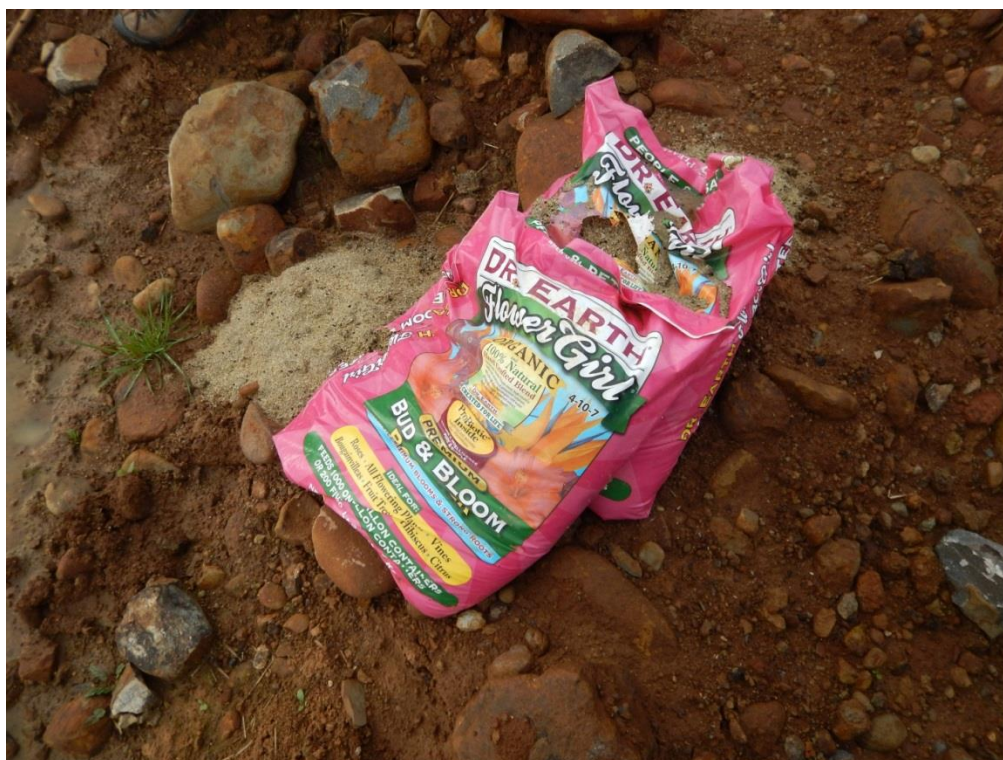
Photograph 12: Leaking bags of Dr. Earth's Flower Girl organic fertilizer.

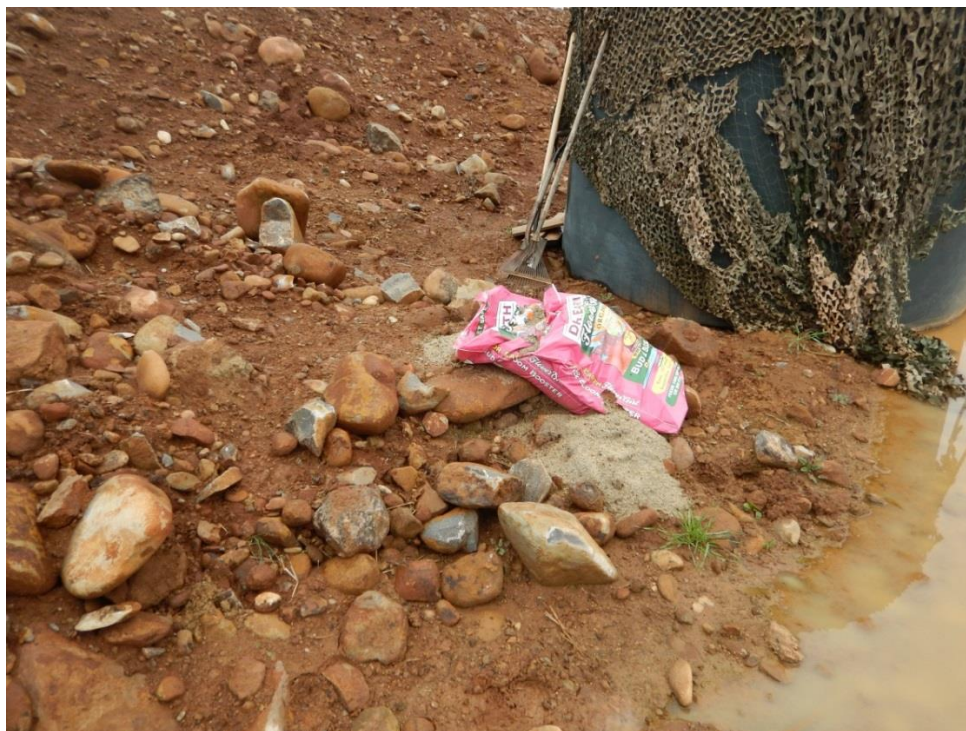
Photograph 13: Leaking bags of Dr. Earth's Flower Girl organic fertilizer adjacent to ponding water – a potential source of nutrients responsible for algal growth.

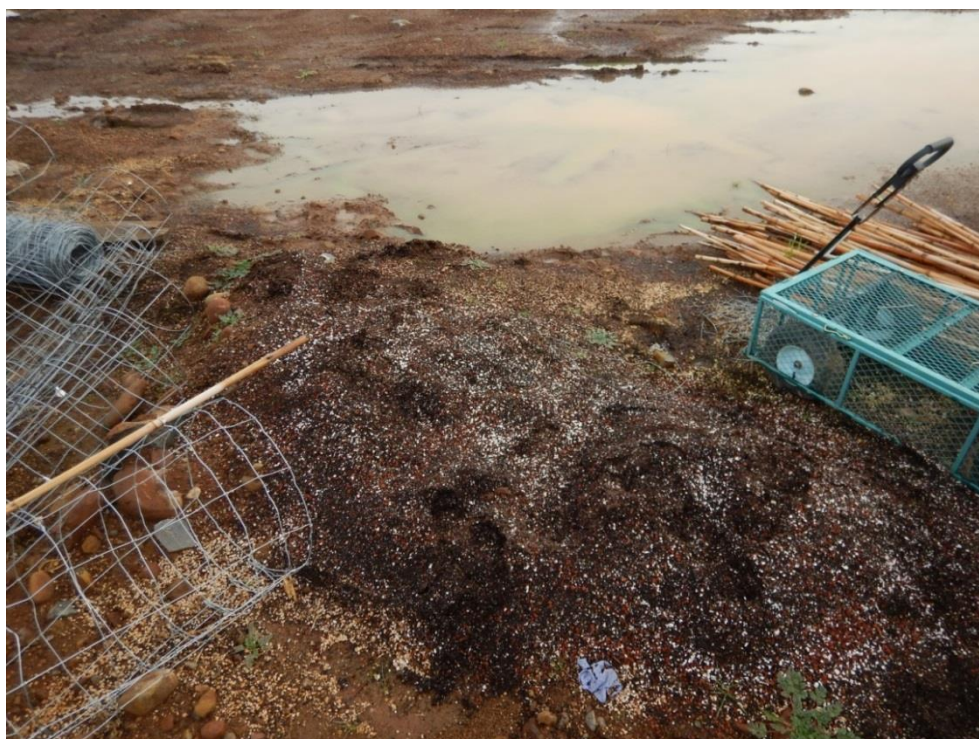
Photograph 14: Loose potting soil and perlite adjacent to ponding water.

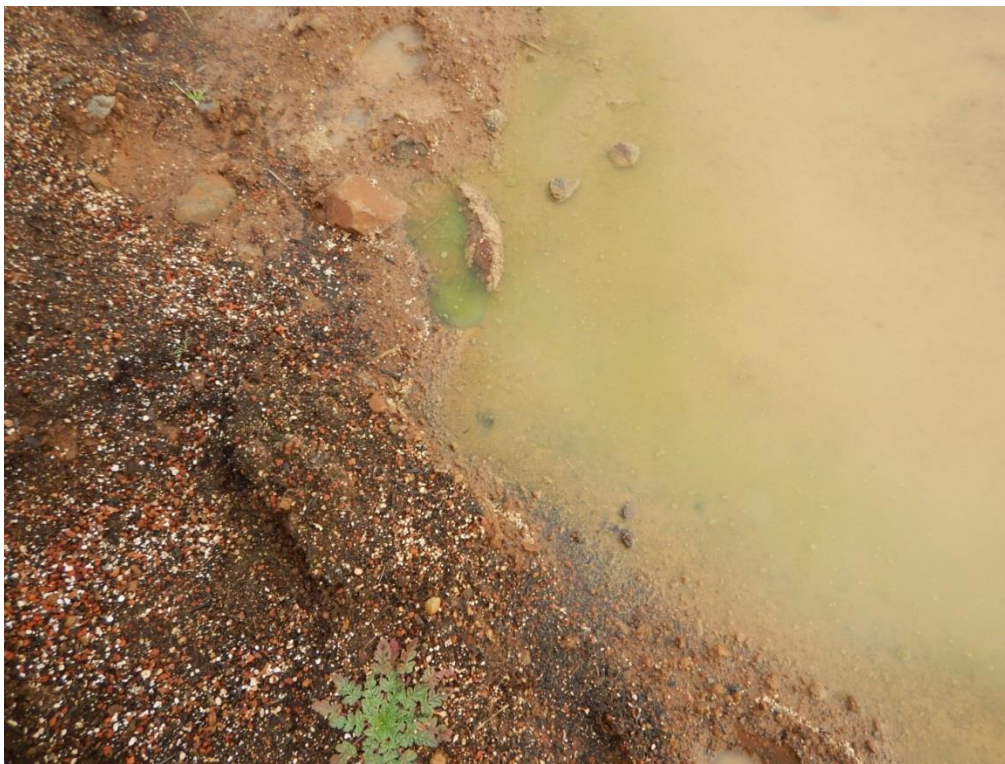
Photograph 15: Loose potting soil with perlite and evidence of algal growth in ponding water.

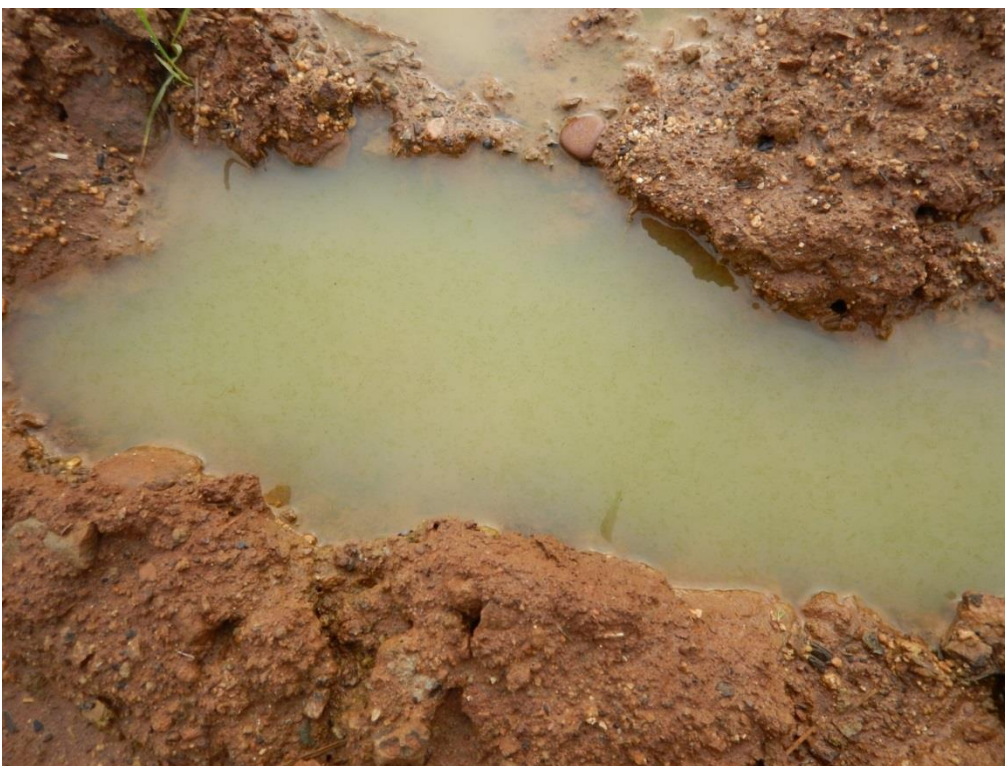
Photograph 16: Algal bloom.

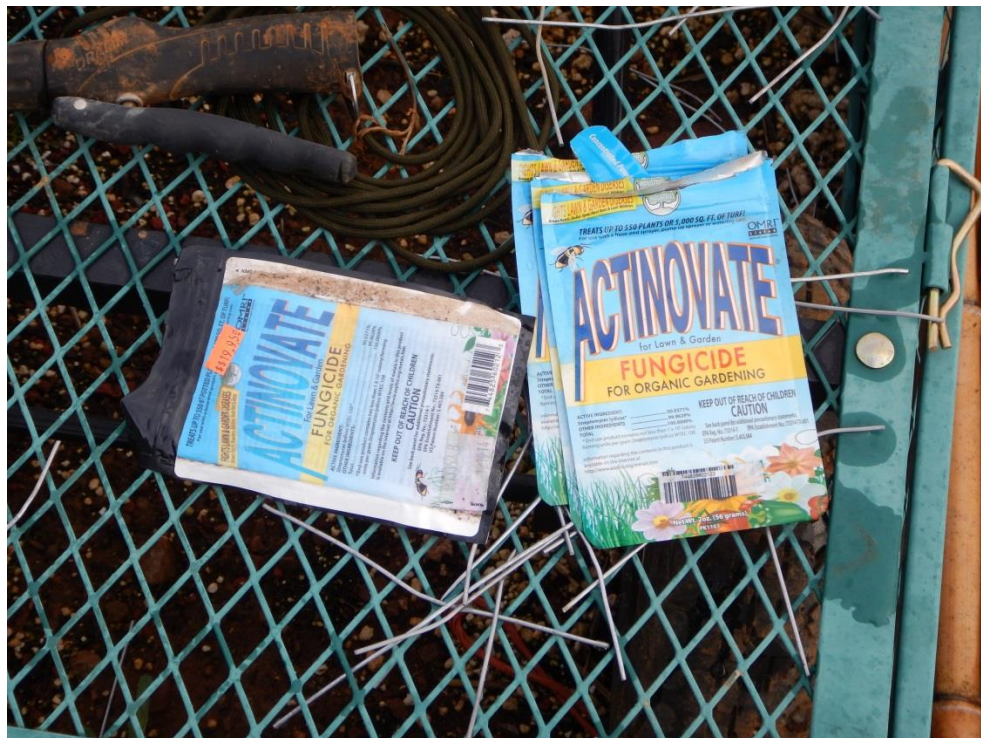
Photograph 17: Uncontained, open packets of Actinovate Fungicide – a bacterial fungicide.

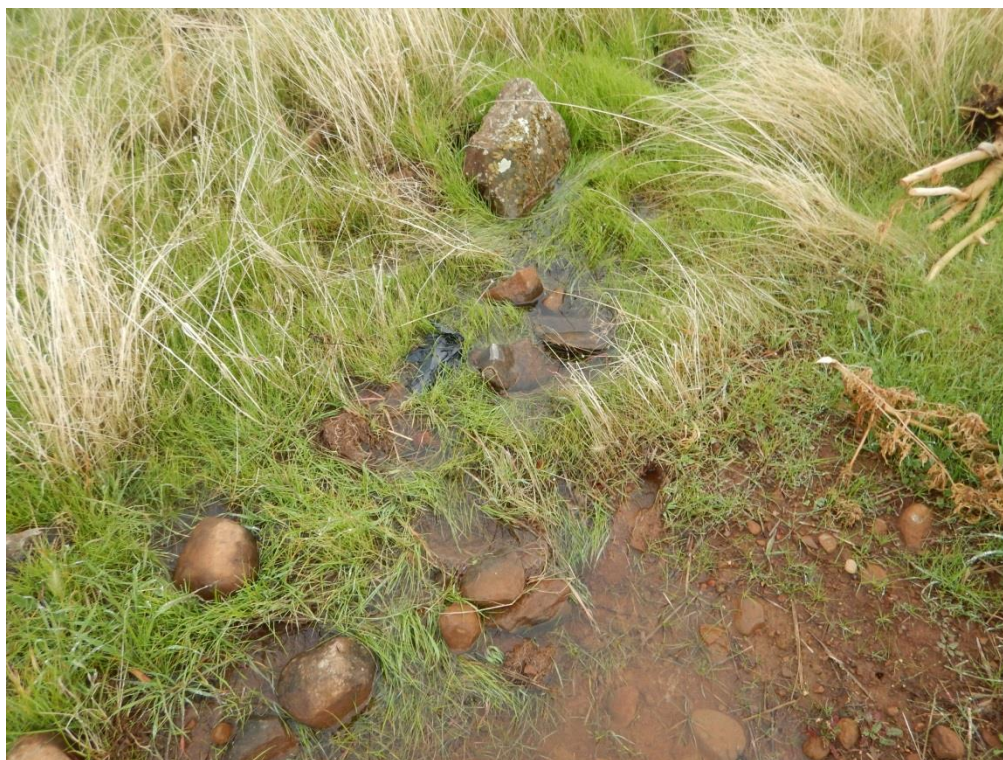
Photograph 17: Ephemeral stream entering the site with low turbidity.

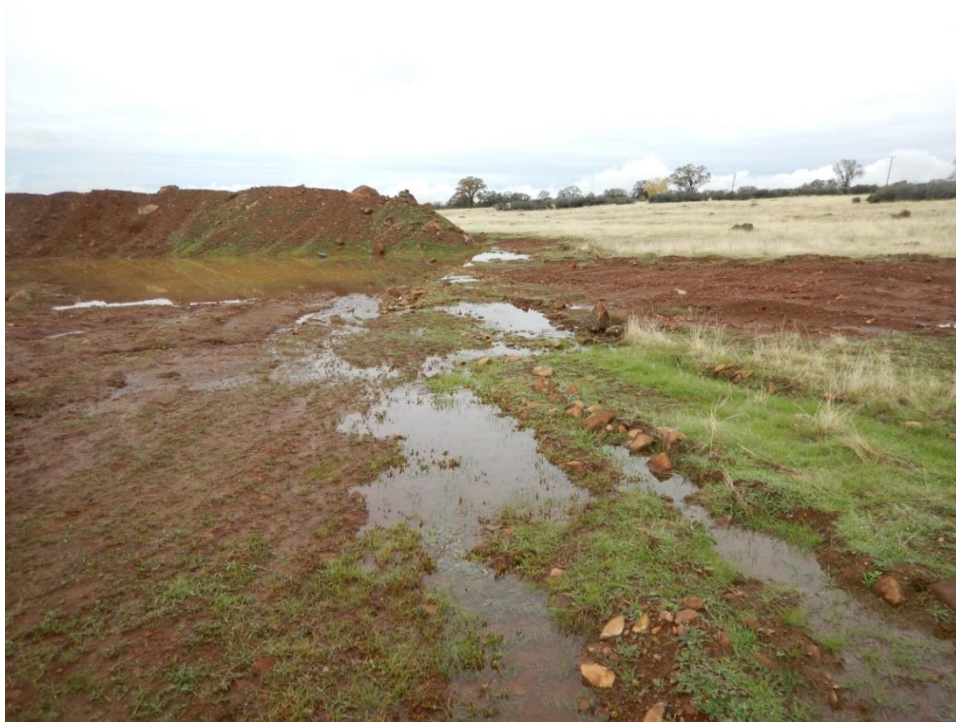
Photograph 18: Stream flowing through the site.

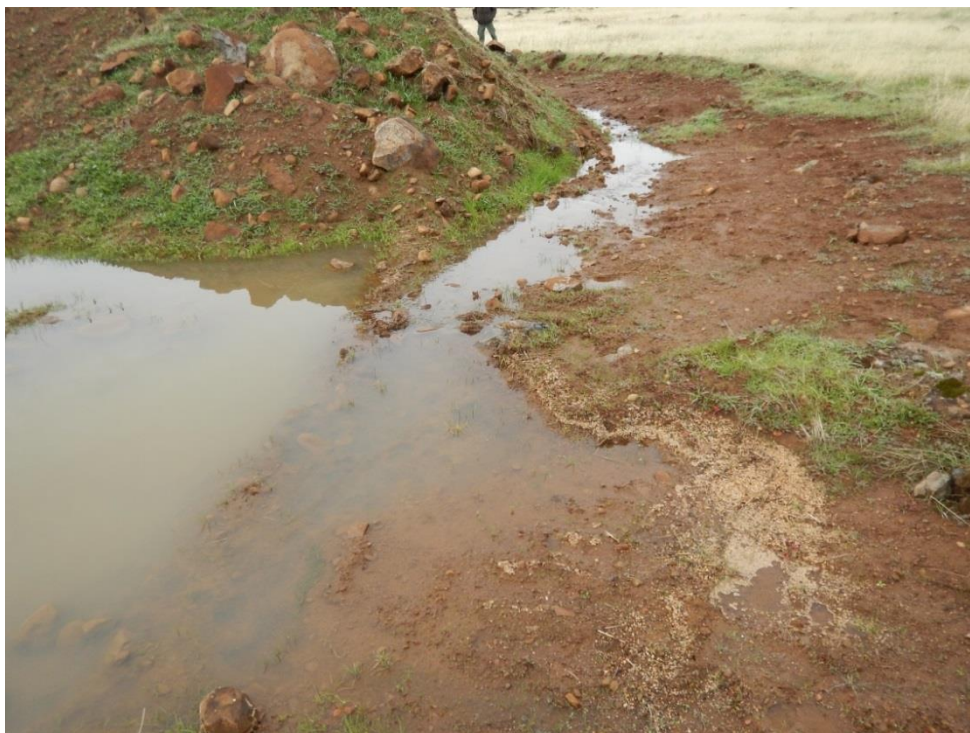
Photograph 19: Turbid stream after converging with waters from the site and picking up sediment from the excavated soils, traveling around the berm lying in its natural path.

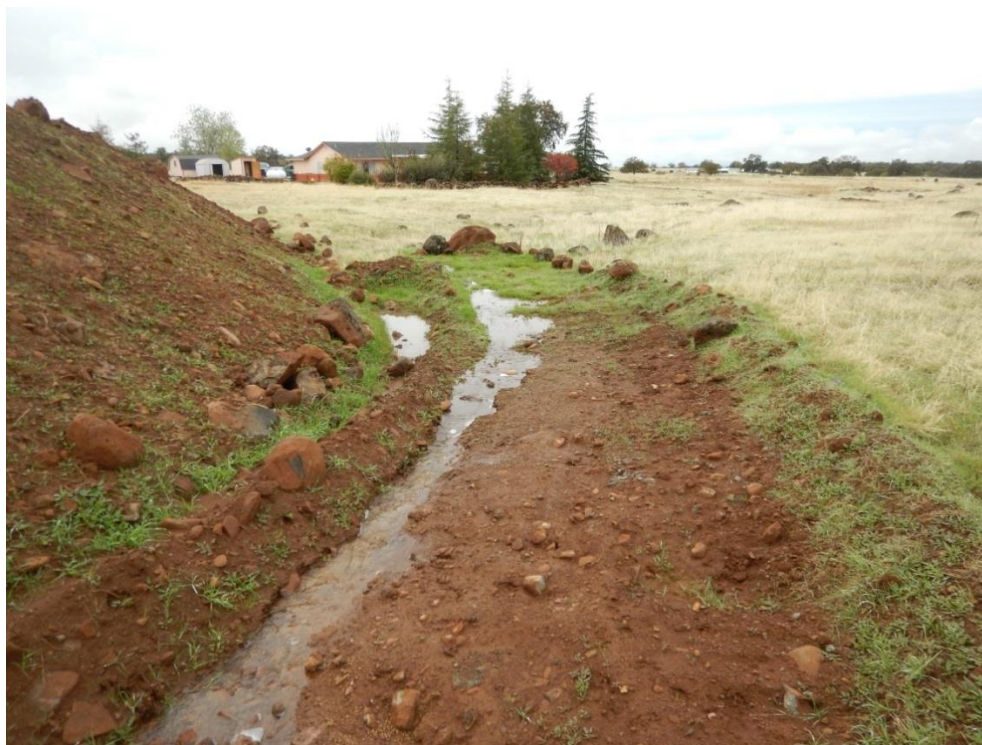
Photograph 20: Stream carving out a new path around the western berm, leaving the disturbed area heading back towards its natural channel.

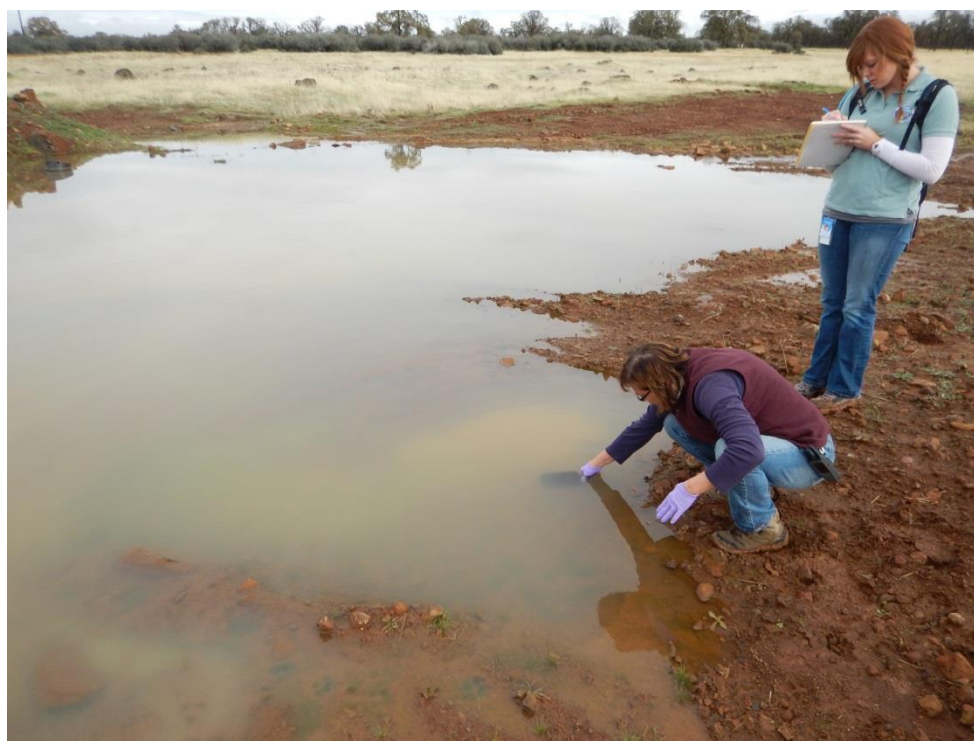
Photograph 21: Sample site #1, Pond\Run-Off Sample - collected from final ponding area before it discharges into stream.

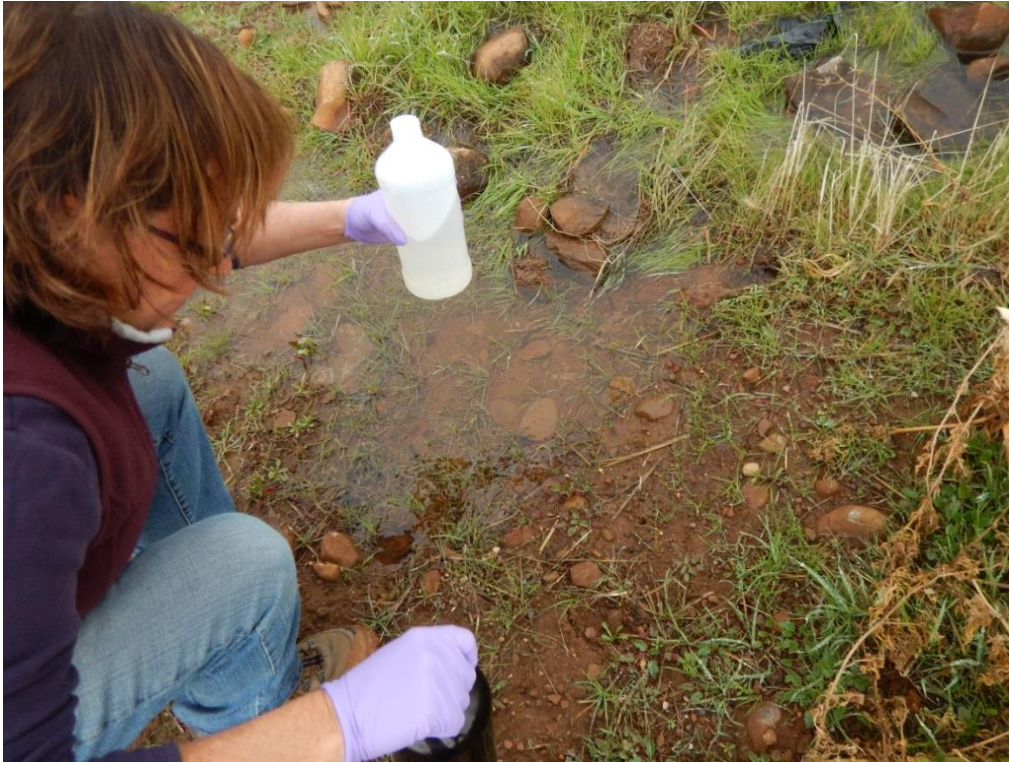
Photograph 22: Sample site #2, Upstream Sample - collected upstream from grow site.

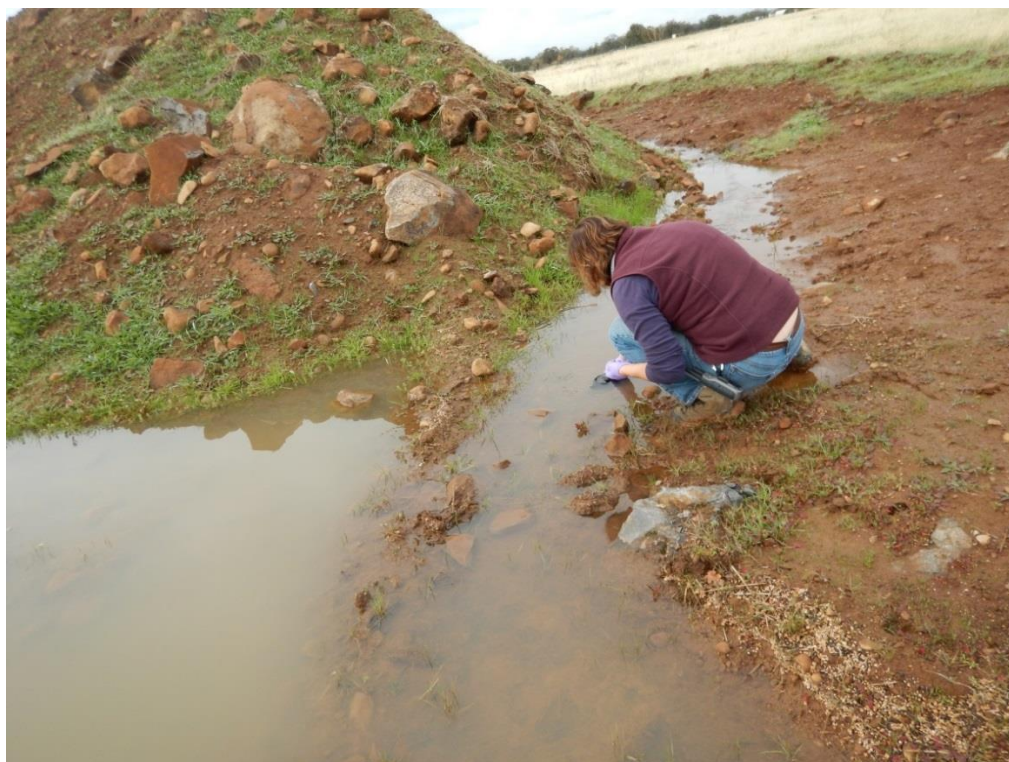
Photograph 23: Sample site #3, Downstream Sample – collected after convergence of stream with site run-off.
